Environmental Assessment Determinations and Compliance Findings for HUD-Assisted Projects 24 CFR Part 58

Project Name: Tahiti Apartment Homes (formerly Tahiti Motel) **Responsible Entity: OC Housing & Community Development Grant Recipient** (if different than Responsible Entity): State/Local Identifier: CA/059 **Preparer:** Liza Santos, OC Housing and Community Development **Certifying Officer Name and Title:** Julia Bidwell, Director OC Housing & Community Development **Consultant** (if applicable): Jonathan Rigg, Dudek 1 SW Columbia Street, Suite 1500 Portland, Oregon 97258 503.956.1444 **Direct Comments to:** Liza Santos, liza.santos@occr.ocgov.com

1.0	INTRODUCTION
2.0	SCOPE OF WORK
3.0	PROPERTY DESCRIPTION
4.0	INSPECTOR'S QUALIFICATIONS
5.0	SAMPLING PROTOCOL / SAMPLE ANALYSIS
6.0	SUMMARY OF RESULTS
7.0	RECOMMENDATIONS
8.0	INSPECTION LIMITATIONS
APP	ENDICES

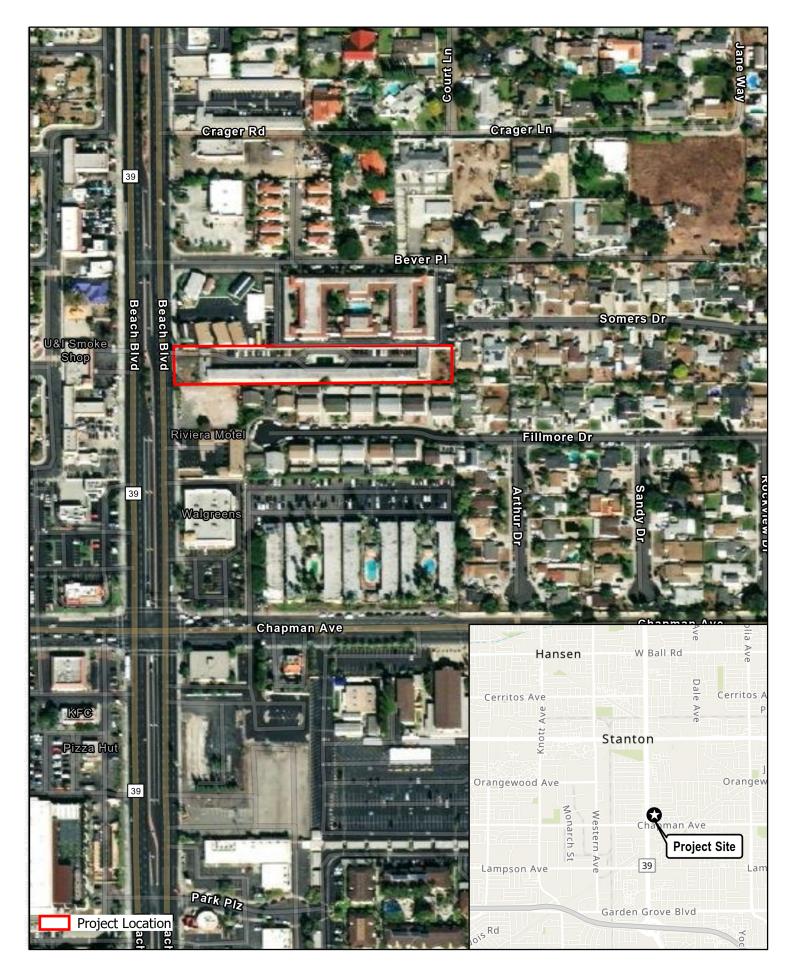
Attachment 1. Project Location

0	250	500 US Feet	Figure 1: Project Location
DUDEKĂ				Tahiti Motel Conversion

See EA Figure 1.

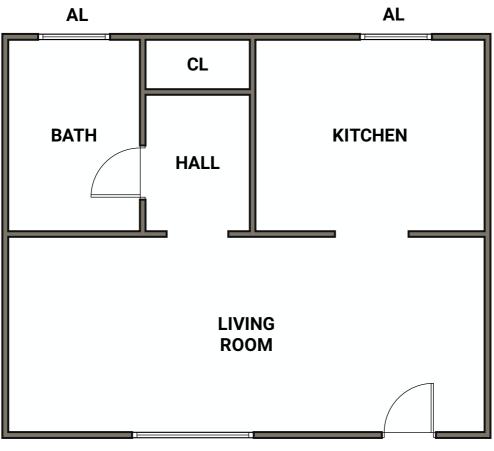
APPENDIX D (MAPS)

Window Kwy: AL= Aluminum Tahiti Motel 11850 Beach Boulevard Stanton, CA Project #3012729

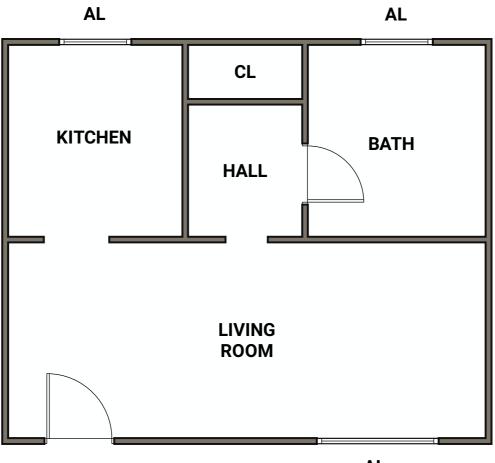
Window Key: AL= Aluminum Tahiti Motel 11850 Beach Boulevard Stanton, CA Project #3012729 Attachment 9. Lead-Based Paint Report
